SALMONID HABITAT LIMITING FACTORS WATER RESOURCE INVENTORY AREA 14, KENNEDY- GOLDSBOROUGH BASIN

**FINAL REPORT
NOVEMBER 2002**

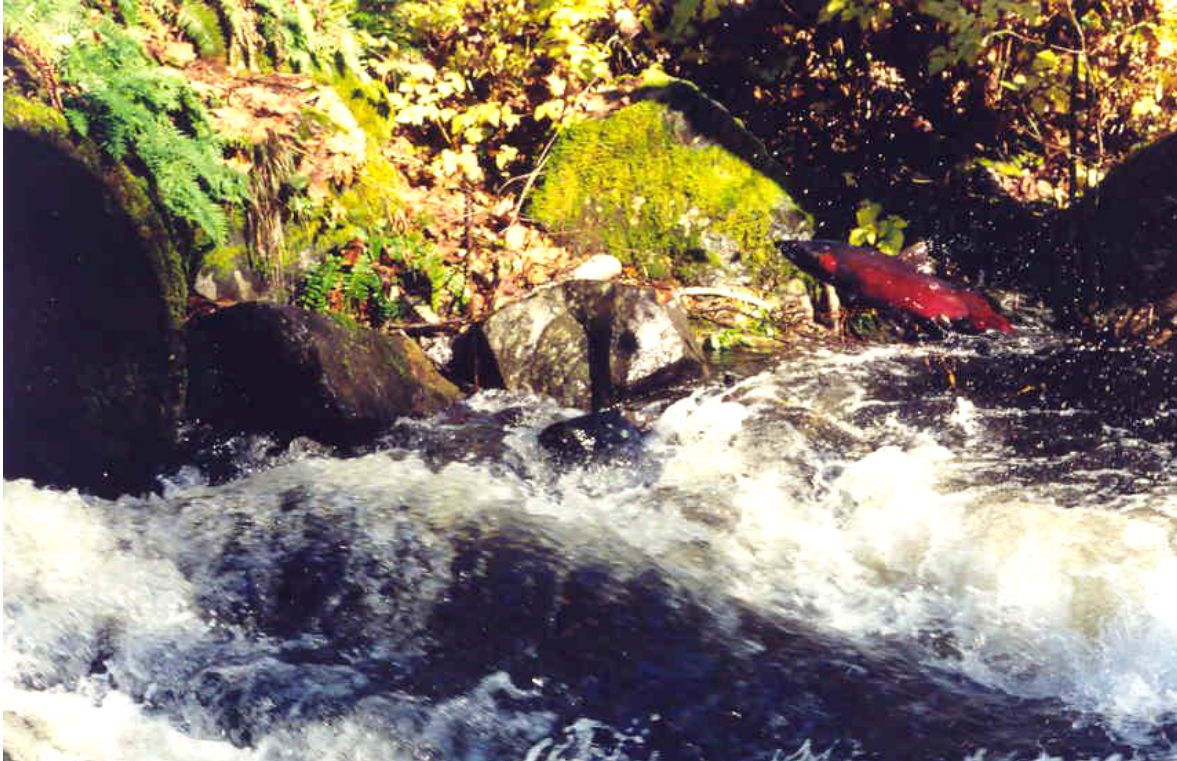
Figure 3. Coho salmon attempting to pass through a culvert at the U.S. Navy railroad bridge on Sherwood Creek (RM 6.8). The undersized culverts caused high water velocities, limiting passage of adults upstream. Photo courtesy of Allyn Salmon Enhancement Group.

Artificial obstructions including dams and culverts can block salmonid migration up and down streams. Depending on the location and longevity of the barrier, the negative effect may be limited to a portion of only one generation, or in extreme cases, the barrier may cause the extirpation [def.](#) of an entire run of fish. Manmade structures that may hinder salmonid migration in the Kennedy-Goldsborough Basin include dams and failed culverts. Natural waterfalls and cascades are common in headwater areas (Figure 3).

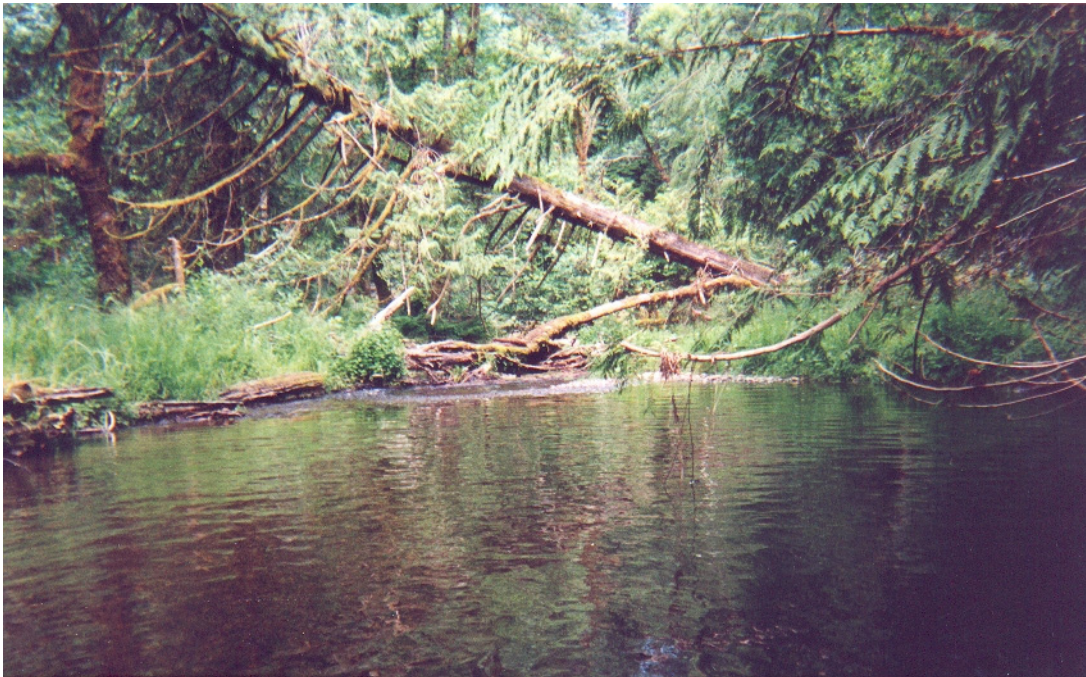
Figure 4. Riparian vegetation along Sherwood Creek, spring 2000. Note the coniferous trees and the trees leaning over the stream, a future source of LWD. Photo courtesy of the Allyn Salmon Enhancement Group.

Leaf litter falling into the stream is an important component of primary production within the aquatic community (Bisson and Bilby 2001), although Murphy (2001) asserts that production by aquatic plants and algae makes a larger contribution. Microinvertebrates (i.e. zooplankton) and macroinvertebrates (larval insects, aquatic snails, etc.) feed on the decomposing organic material. Fish and other animals in turn feed on the smaller organisms (Bisson and Bilby 2001). Mature trees in the riparian zone also provide important function when they are knocked into streams by floods, windthrow, or landslides. These woody materials are known as large woody debris (LWD). Large woody debris stabilizes streambeds and banks, captures spawning gravels, encourages pool formation, provides resting and hiding cover for salmonids, and creates habitat for insects and other forage important to salmonids (Bilby and Bisson 2001). Finally vegetation within the riparian zone filters soil and pollutants from stormwater runoff (Knutson and Naef 1997, Welch *et al.* 2001) and reduces flood damage by slowing down flood waters, thereby dissipating energy and capturing soil carried in the flood waters (Naiman *et al.* 2001) (Figure 4).

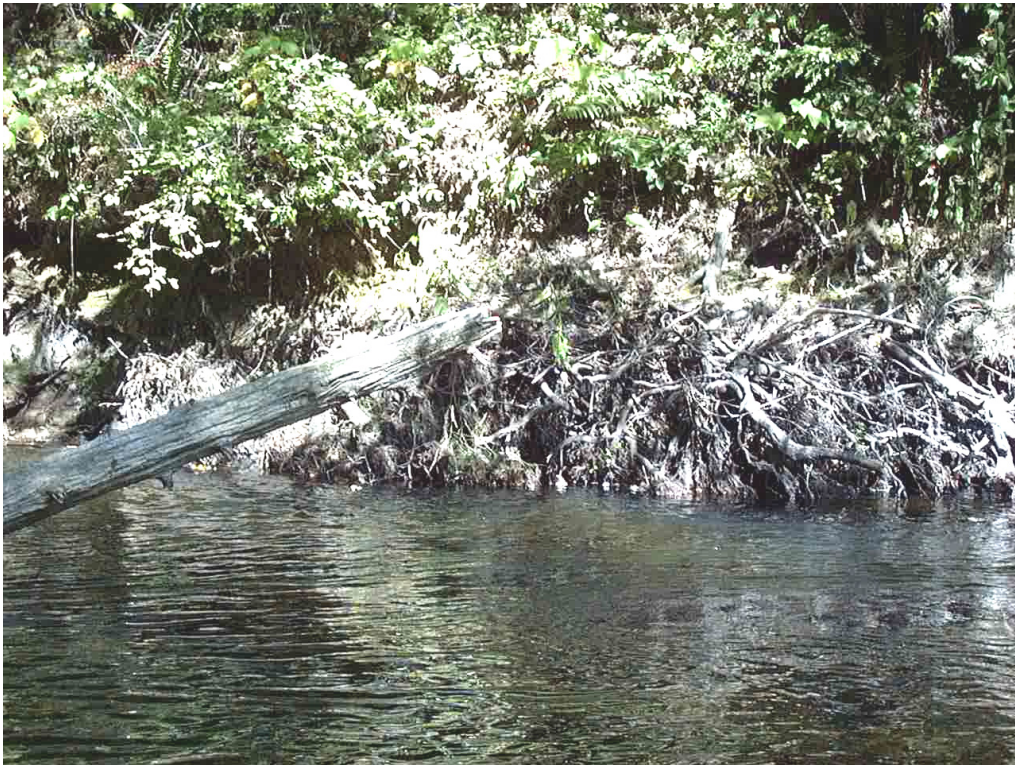
Figure 5. Tree roots enhance bank stability and lead to formation of undercut banks, instream cover for salmonids. Photographed late August 2002, upstream from former Simpson Dam site on Goldsborough Creek.

Natural streambank stability maintains the integrity of riverine processes. The root masses of riparian vegetation and large woody debris stabilize streambanks (Figure 5). Riparian zones can maintain or repair themselves if they are located on a stable bank. Vegetation has a difficult time recovering from flood damages or other disturbances if it is continually undermined by a failing bank (Naiman *et al.* 2001). Stable streambanks also ensure an adequate channel depth. A given volume of water is deeper in a narrow

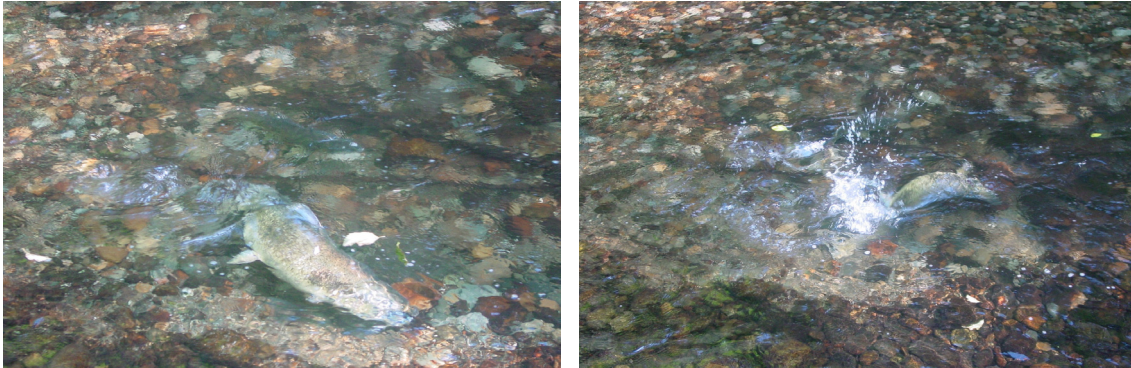
Figure 6. Clean-unembedded gravel provides quality salmonid spawning habitat. Chinook salmon spawning in Sherwood Creek September 2002. Photos courtesy of the Allyn Salmon Enhancement Group.

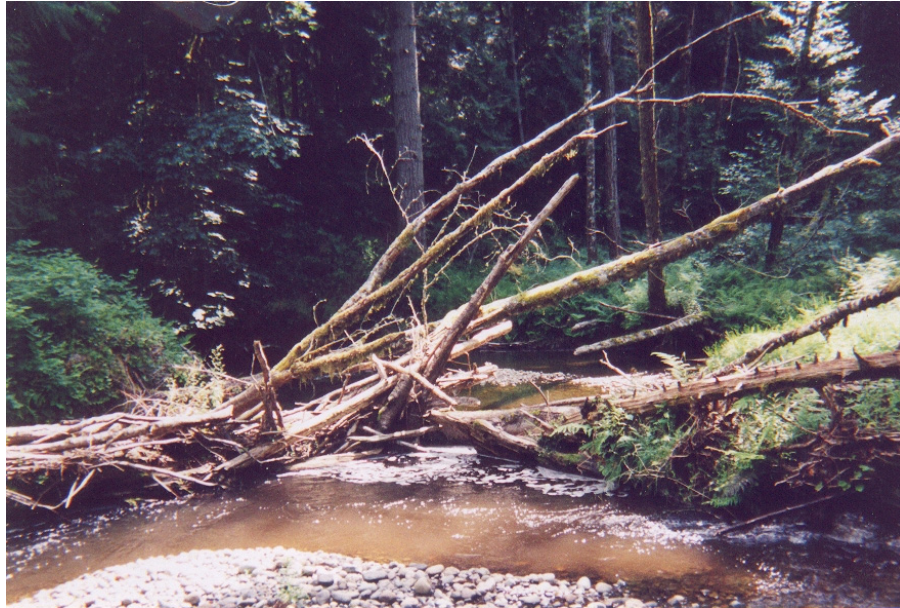
Figure 7. This logjam on Sherwood Creek has created a pool with instream and overhead cover and is stabilizing the stream banks. Photo courtesy of the Allyn Salmon Enhancement Group.

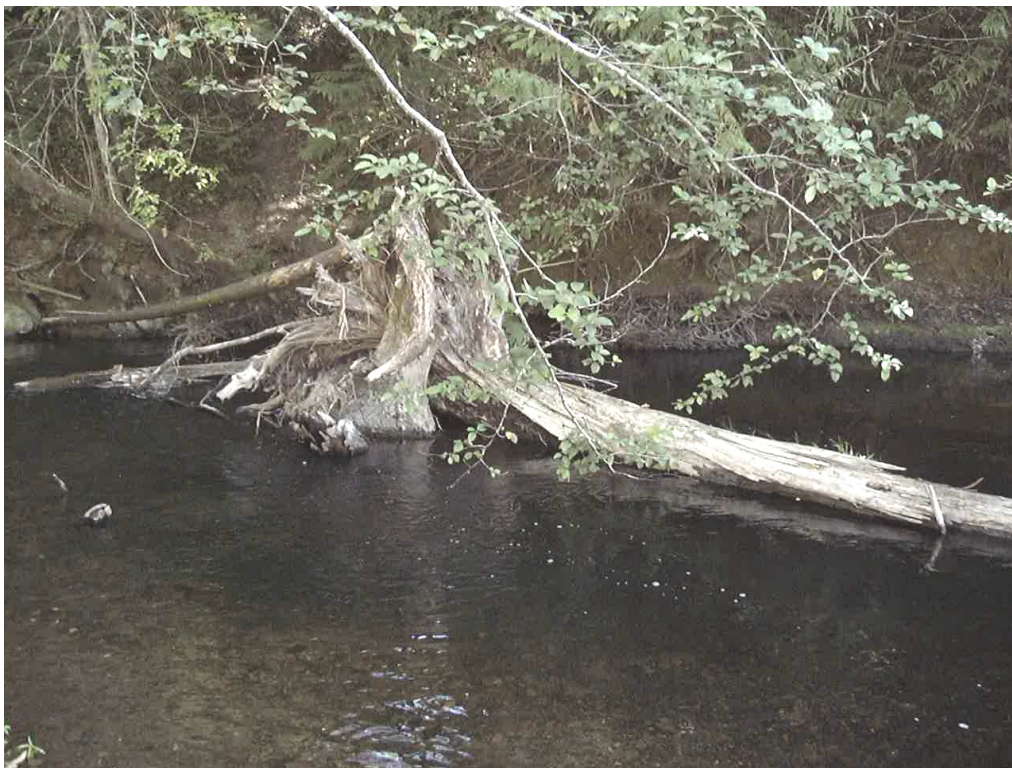
Figure 8. Though only about three feet deep, this pool exhibits many elements of a quality pool. The fallen tree provides instream cover while riparian vegetation provides overhead cover and shade. The pool is much deeper than the surrounding water. Photographed in late August 2002 upstream from the former Simpson Dam site on Goldsborough Creek.

Important features of pools are size, depth, and cover (both instream and overhead). Generally speaking, the more size, depth, and cover that are present, the higher the quality of the pool. Large-deep pools with lots of cover provide many hiding areas, ample forage, and cool water temperatures. An abundance of pools interspersed with riffles combine to create ideal salmonid habitat (Figure 8).

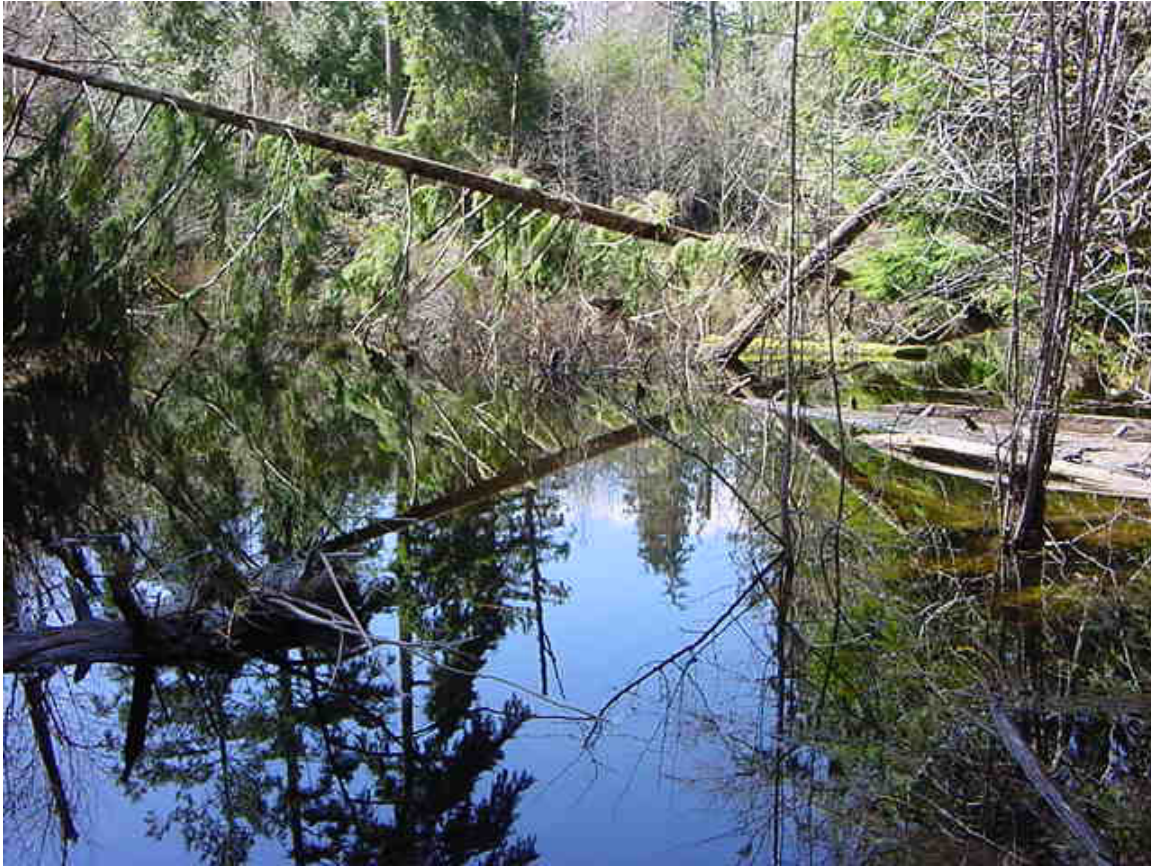
Figure 9. This beaver pond in the Sherwood Creek Watershed is an example of off-channel habitat. Ponds such as this are excellent rearing habitat for coho salmon and cutthroat trout. Abundant woody debris provides cover, while the pond provides shelter from low summer and high winter stream flows. Photo courtesy of the Allyn Salmon Enhancement Group.

Beaver ponds, wetlands, oxbow ponds, and side channels connected to the main river channel are all forms of off-channel habitat. Juvenile salmonids (especially coho salmon, and cutthroat trout, and to a lesser extent, rainbow/steelhead trout) seek out this type of habitat for rearing, particularly during winter high flows. Off-channel areas provide an abundance of food with fewer predators than would typically be found in the river. These areas also generally have reduced current and large amounts of vegetative and/or woody cover, allowing juvenile salmonids to hide from predators and conserve energy (Sandercock 1998). Diking, and channelization of rivers, conversion of riparian zones to pasture and cropland, floodplain development, and extermination of beaver all play a roll in destruction of off-channel habitat (Figure 9).

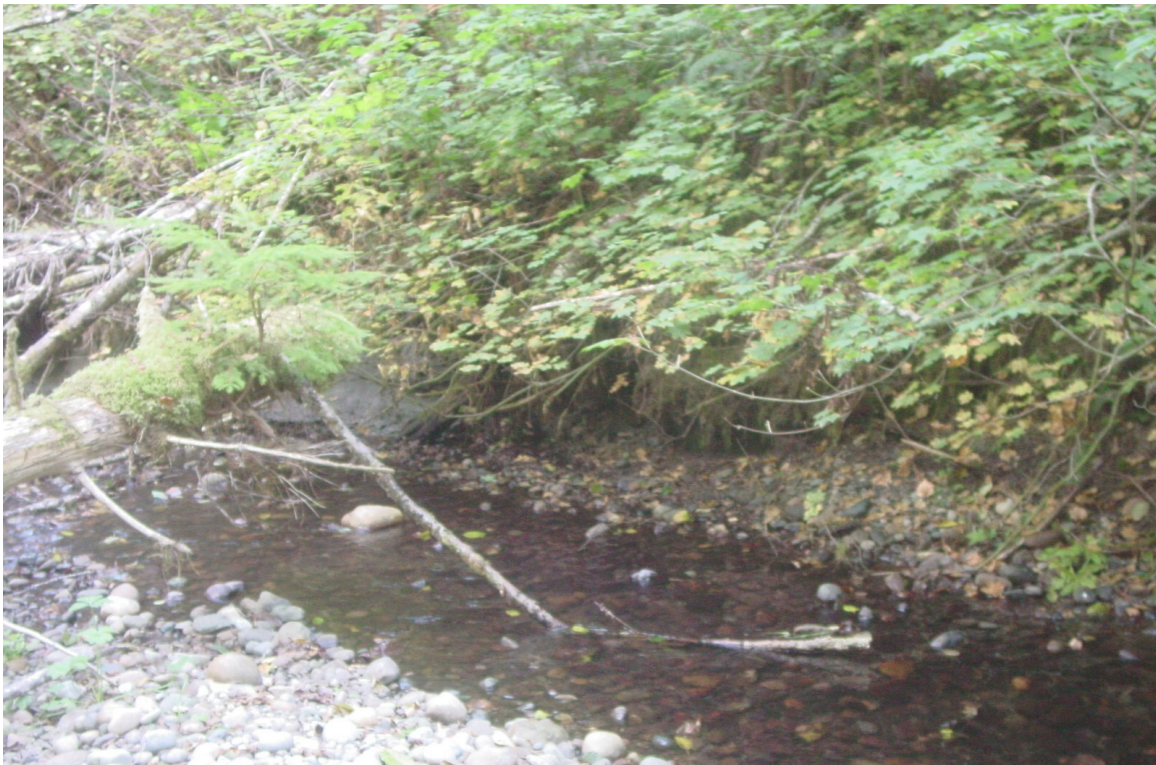
Figure 10. Flows in late September 2002 in a stream in the Sherwood Creek Watershed. The small wetted area and shallow depth provide little salmonid rearing habitat. Photo courtesy of the Allyn Salmon Enhancement Group.

Streams in WRIA 14 are rainfall dominated. The generally low elevation of the majority of the basin limits winter snow pack. The summer months bring naturally low stream flows that are further reduced by groundwater withdrawals along some streams (Stevie 2002, personal communication). Most rainfall occurs from October through May. Summers are relatively dry and ground water supplies are almost entirely recharged from precipitation. Much of the precipitation that falls in the Black Hills runs off because of the impermeable nature of the basalt rock. This causes many headwater streams to go dry during the summer months. Precipitation that falls on the unconsolidated sediment of the glacial plain tends to percolate into the groundwater, providing perennial flow to lowland streams. Groundwater provides the majority of late summer flow to area streams (Molenaar and Noble 1970). The natural climate, degraded watershed conditions, and surface and groundwater withdrawals may all contribute to low and/or subsurface flows. If flows are too low or channels are completely dewatered, little or no quality habitat remains for salmonids. Low summer flows limit salmonid rearing habitat throughout the WRIA (Washington Department of Fisheries 1975, Blakley *et al.* 2000, Golder Associates 2002). As flows decrease, water temperatures usually increase. Migration is hindered or completely blocked and fish are more vulnerable to predation and competition for limited space (Figure 10).

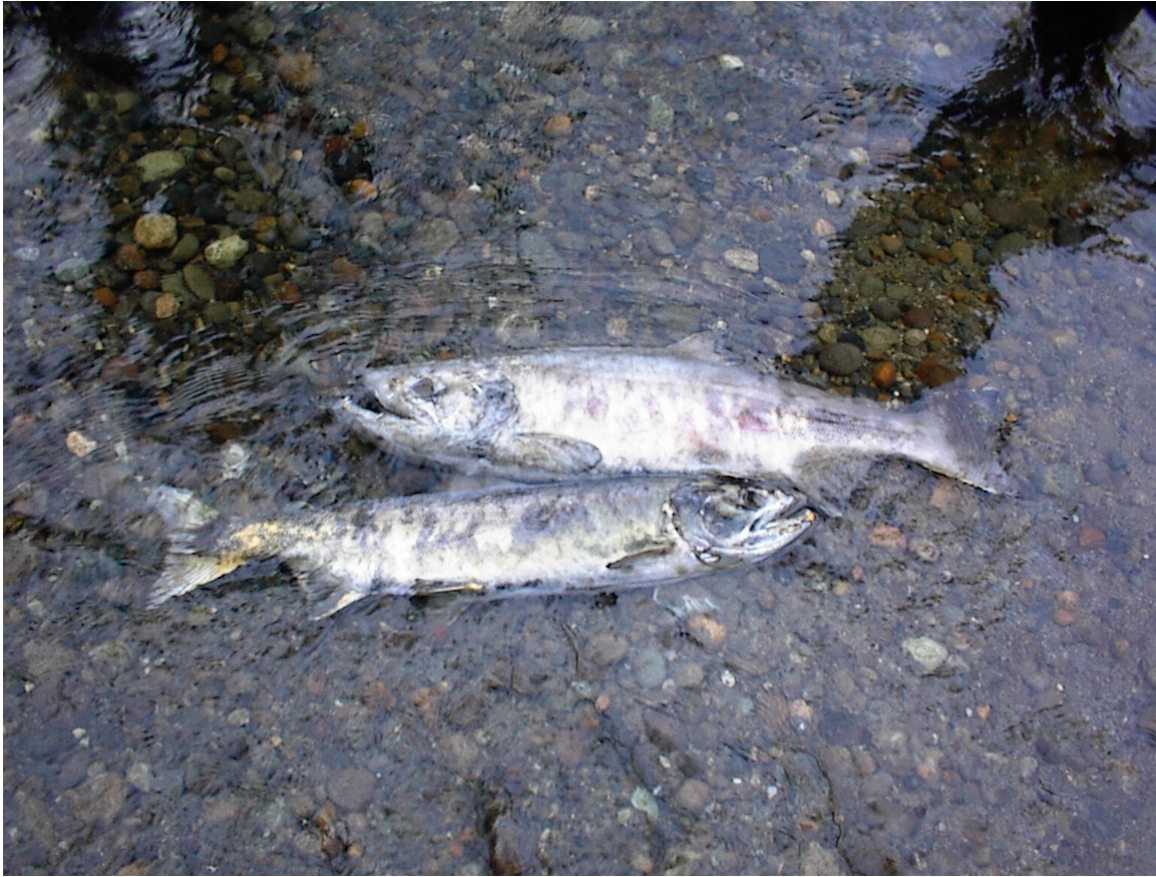
Figure 11. Chum salmon carcasses in Anderson Lake Creek. Decomposing anadromous fish carcasses contribute ocean-derived nutrients to freshwater ecosystems. Photo courtesy of the Allyn Salmon Enhancement Group.

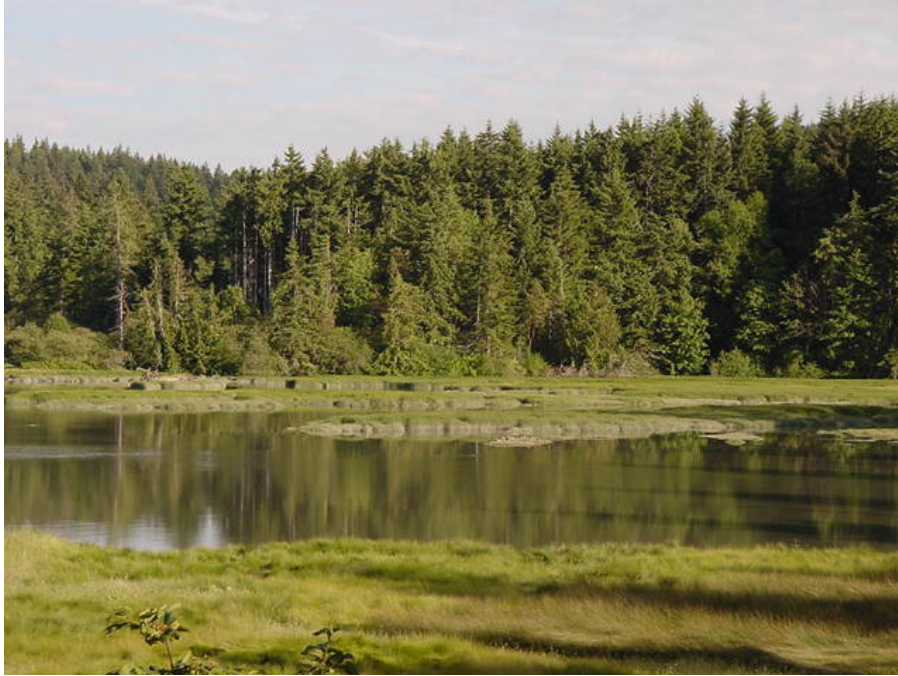
Figure 12. Kennedy Creek Estuary. Note the emergent vegetation and multiple tidal channels. Photo courtesy of the Squaxin Island Tribe.

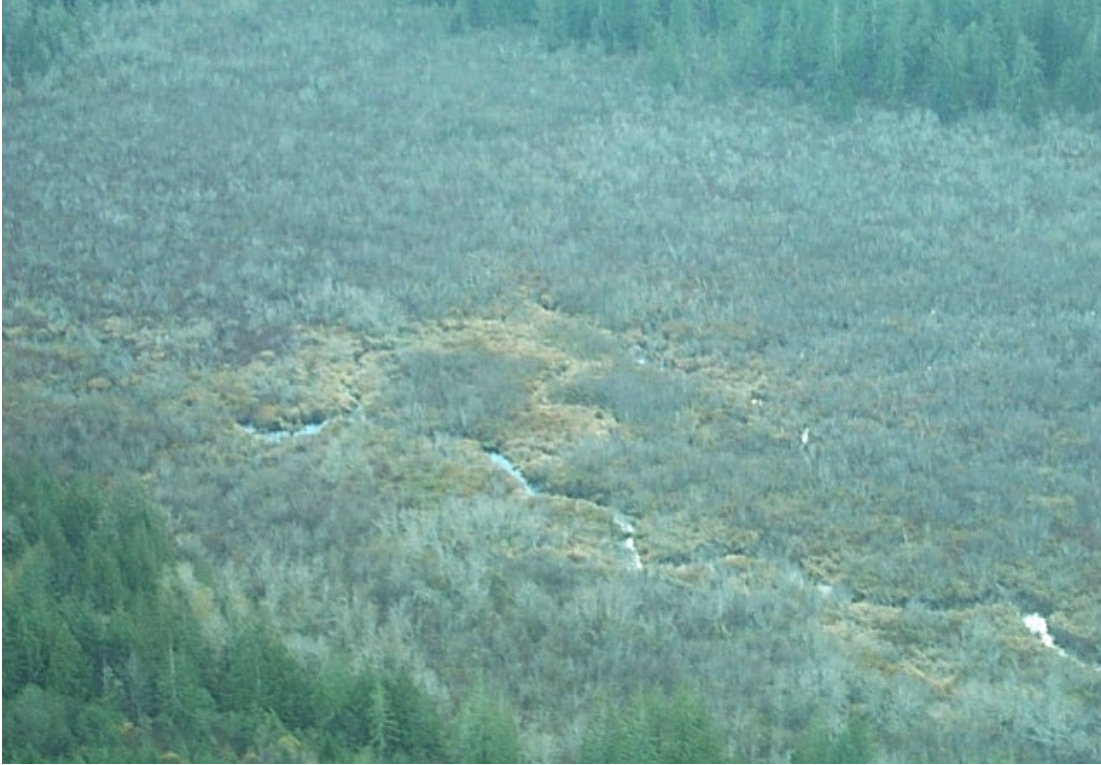
Figure 15. Floodplain of lower Schumocher Creek. Note the large expanse of wetlands and multiple channels. Photo courtesy of the Allyn Salmon Enhancement Group.

Schumocher Creek flows through numerous wetlands (TAG 2002). Floodplain connectivity was rated good.

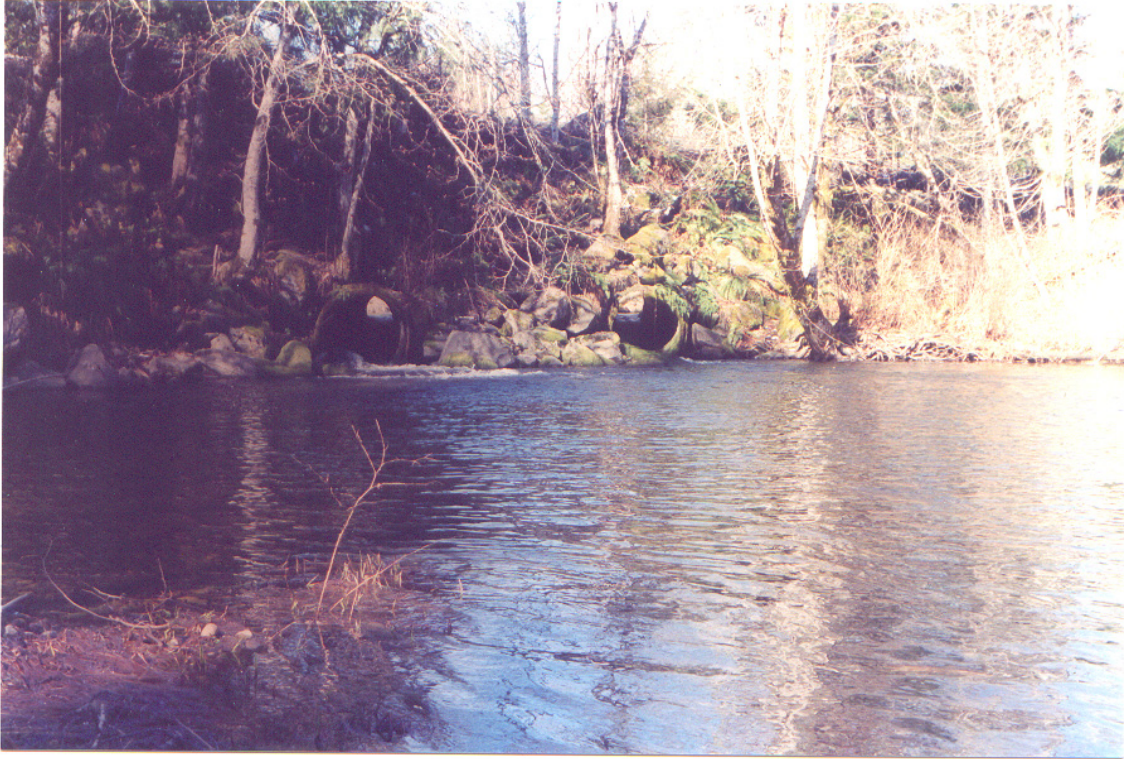
Figure 16. Culverts under the U.S. Navy railroad crossing on Sherwood Creek (RM 6.8) prior to replacement with a bridge in fall of 2002. Photo courtesy of the Allyn Salmon Enhancement Group.

Two undersized culverts under the U.S. Navy railroad line (RM 6.8) historically impeded passage of anadromous fish (Northwest Indian Fisheries Commission 2002) (Figure 16). The culverts were replaced with a bridge in the fall of 2002 (TAG 2002) (Figure 17). A culvert at the mouth of Anderson Lake Creek (14.0095) was historically a barrier to anadromous fish (Northwest Indian Fisheries Commission 2002). The culvert was replaced with a passable structure in the fall of 2002 (TAG 2002). Several barriers are present on stream 14.0098 (Prickett Lake outlet). Anadromous fish are present up to the second barrier. See [Map 12](#). Fish passage was rated fair.

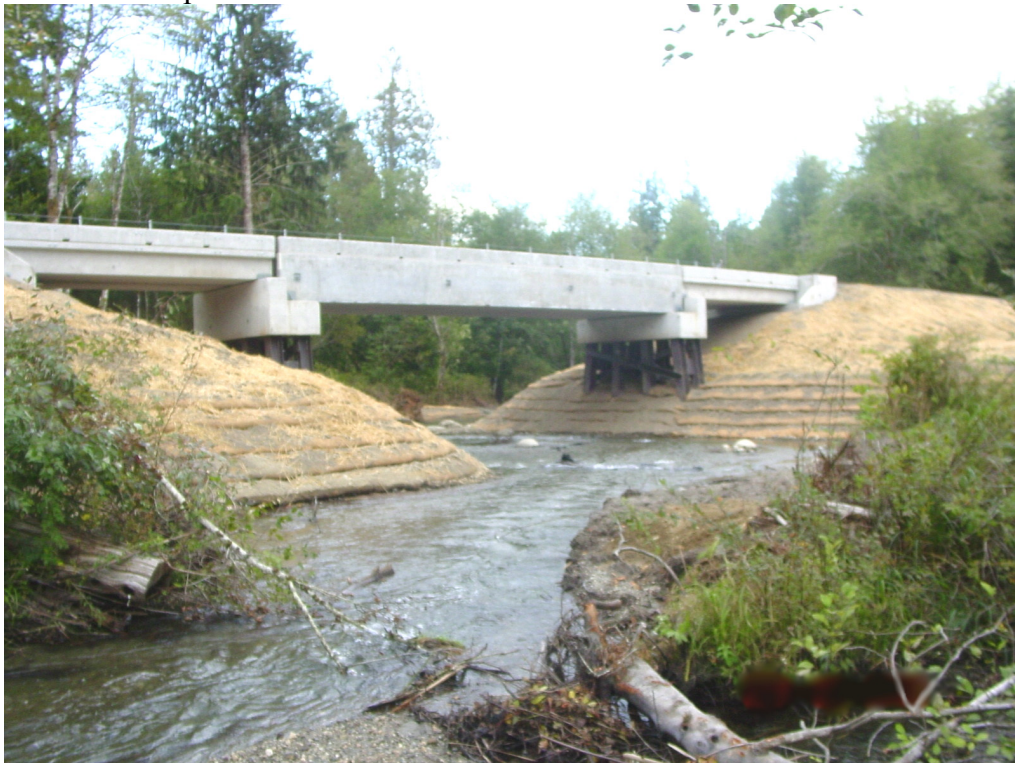
Figure 17. U.S. Navy railroad bridge at RM 6.8 on Sherwood Creek constructed in fall 2002. Compare to Figure 16. Photo courtesy of the Allyn Salmon Enhancement Group.
